The following is a sample of photographs, taken by personnel from VA Dept of Environmental Quality (DEQ), at Shoosmith Landfill, Chesterfield County, VA, between August, 2024 and July, 2025, while inspecting the facility.

VIRGINIA DEPARTMENT OF ENVIRONMENTAL QUALITY

Site Name: Shoosmith SLF Permit# SWP-587

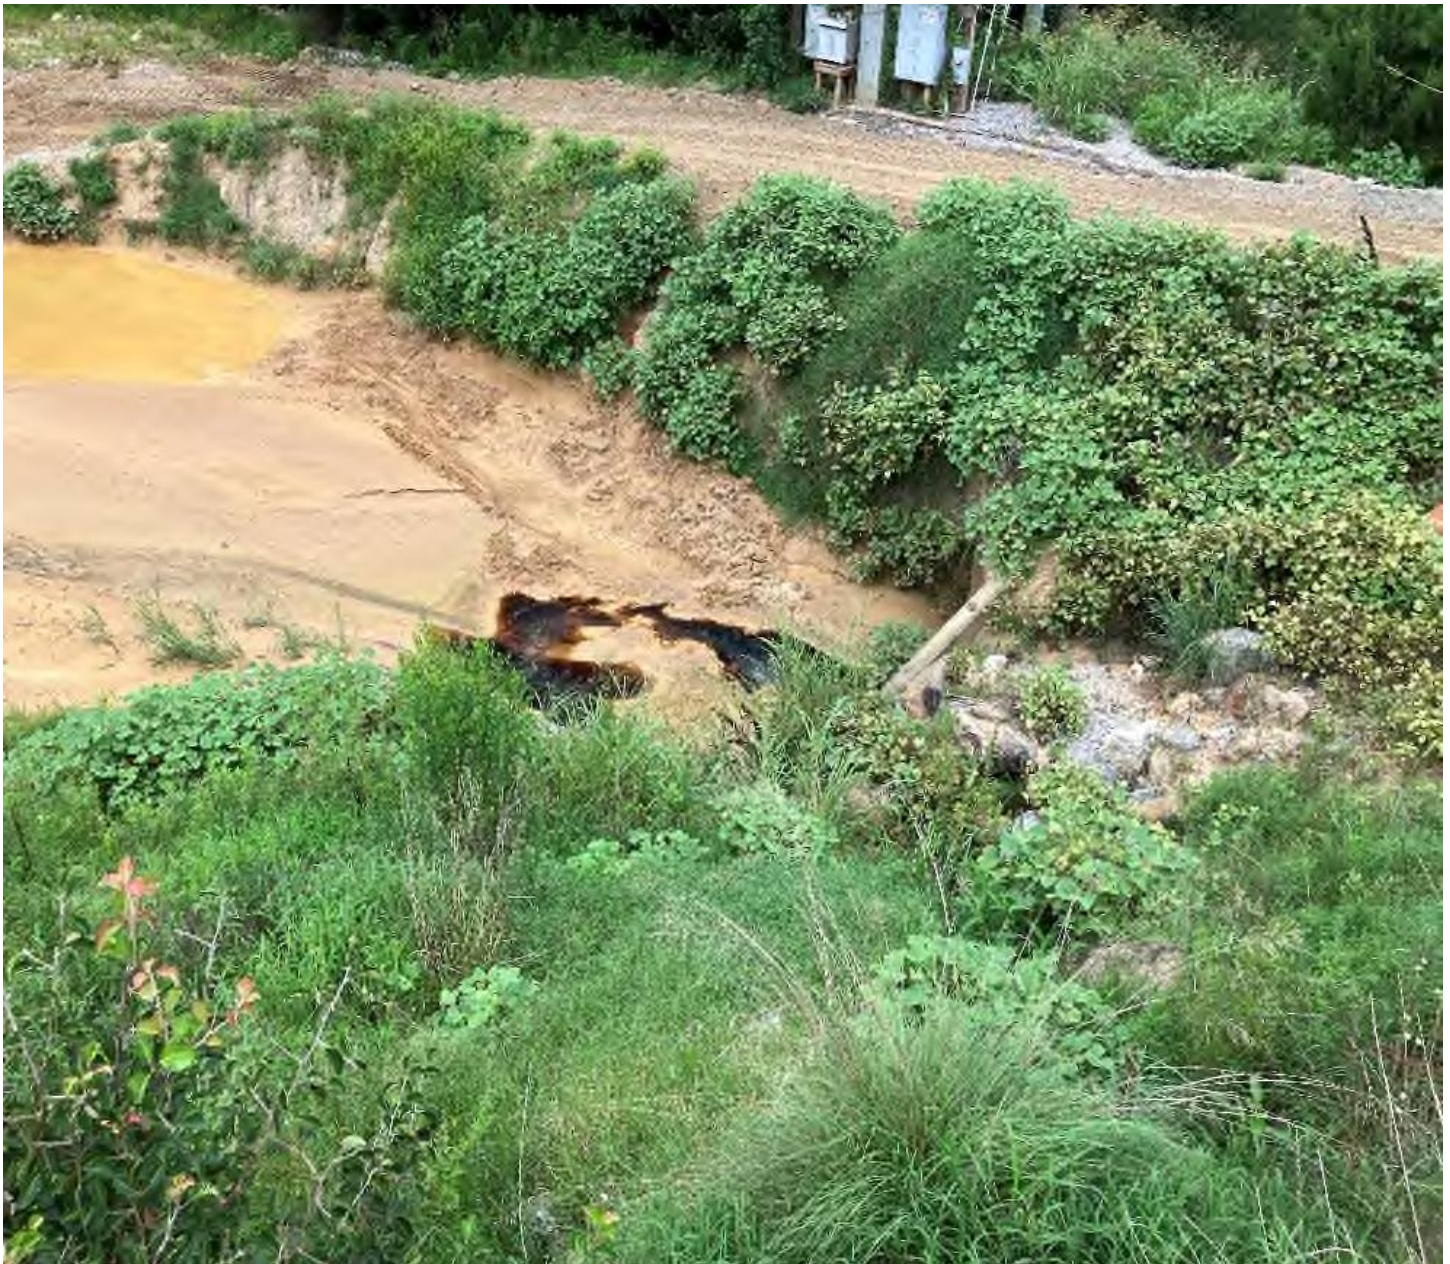
Photo Number: 1

Comments: Picture of leachate that had traveled and pooled into the forebay of SB-11

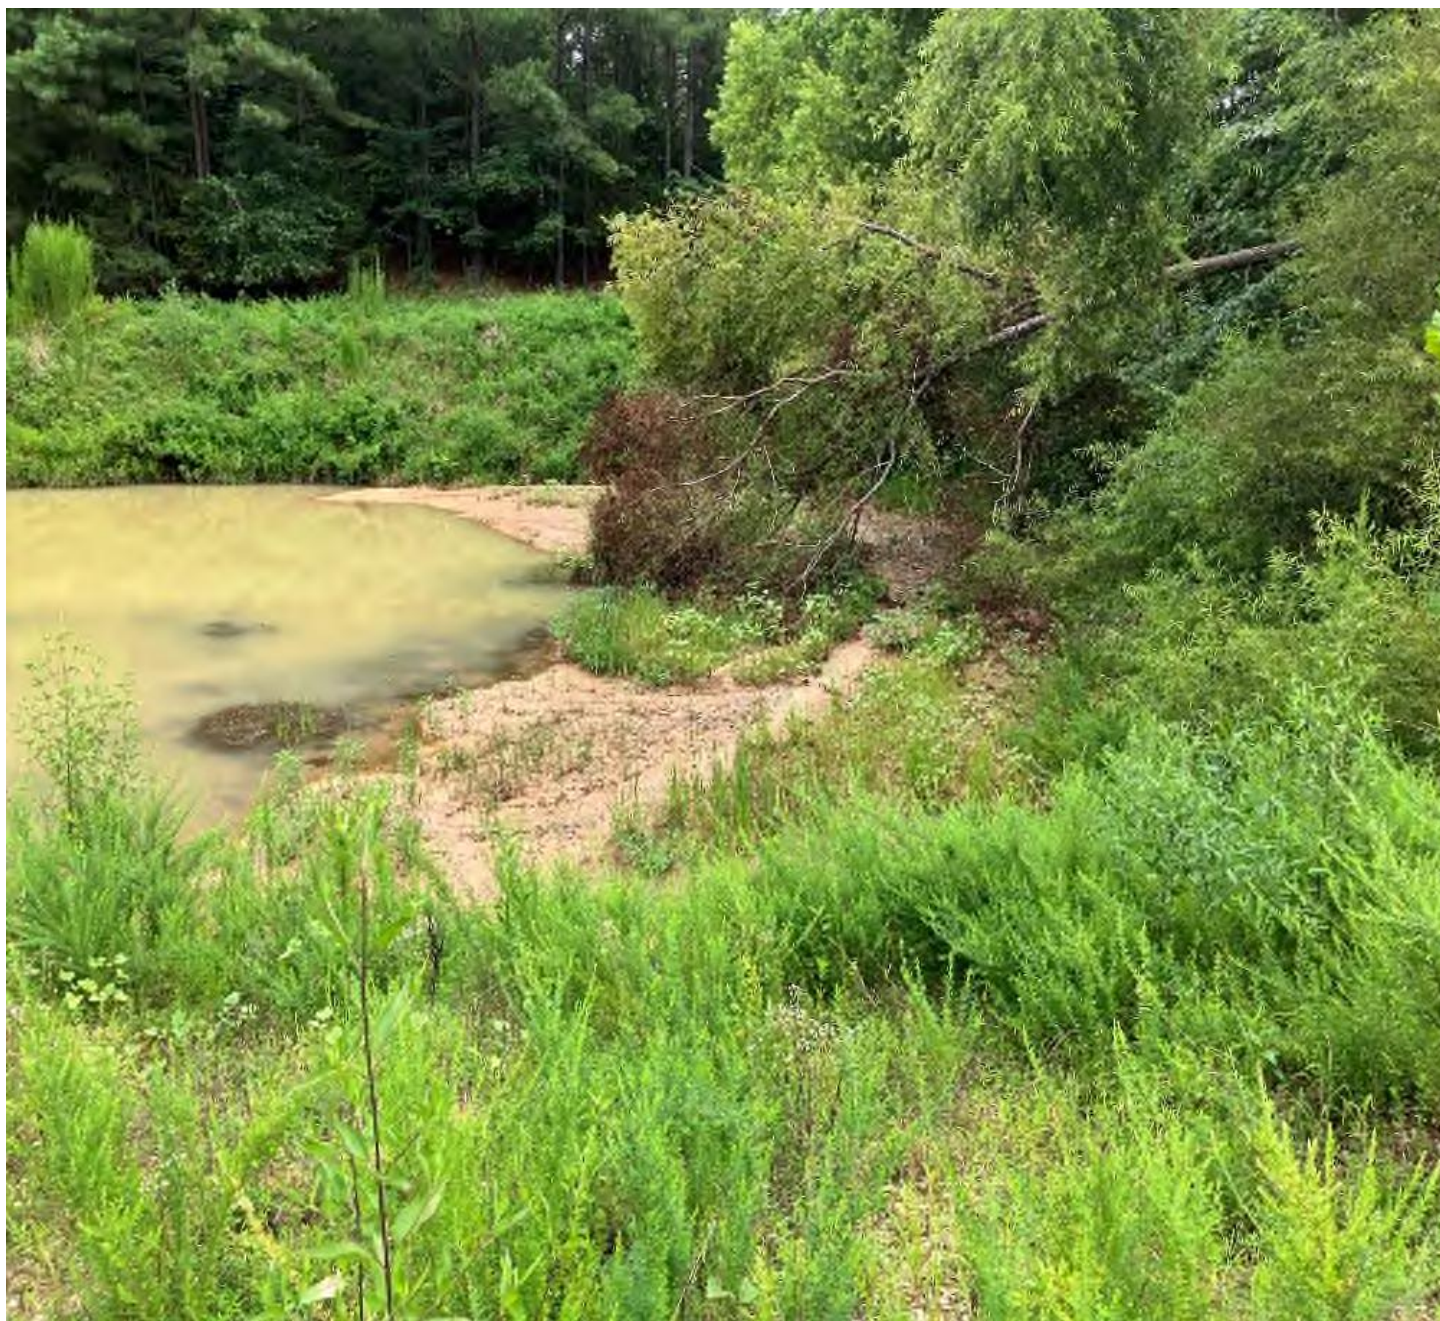
Site Name: Shoosmith SLF Permit# SWP-587  
Taken By: Doug Masini Photo Number: 4  
Date: 8-7-2024  
Comments: Picture of sediment buildup in  
SB-8.

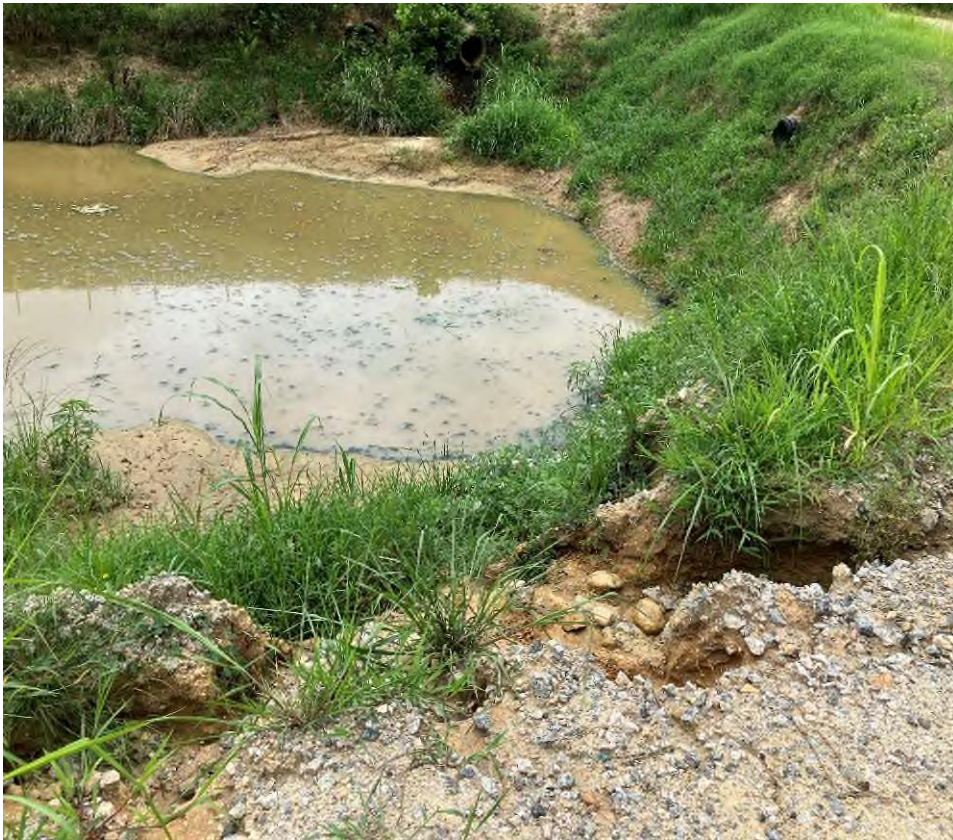
Site Name: Shoosmith SLF  
Taken By: Doug Masini  
Permit# SWP-587  
Photo Number: 7  
Date: 8-7-2024  
Comments: Picture of stormwater diversion which occurred along the backside of SB-4 that caused erosion of the basin wall.

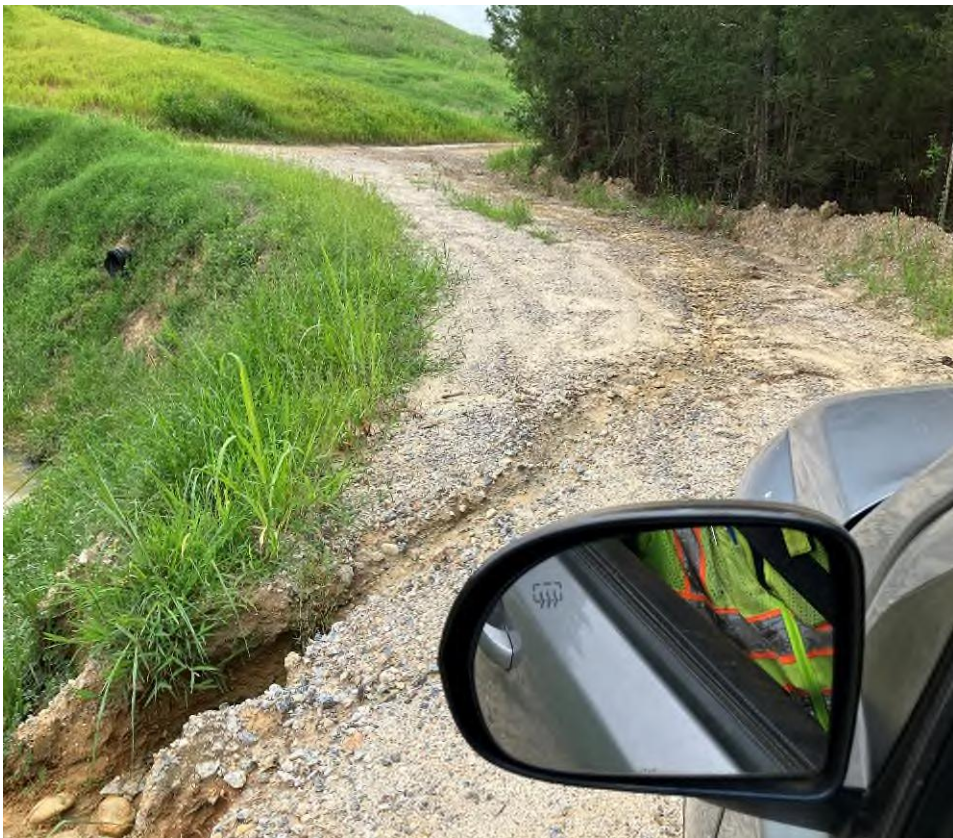
Photo Number: 8  
Date: 8-7-2024  
Comments: Picture of stormwater diversion path along the access road which caused erosion of the basin wall.

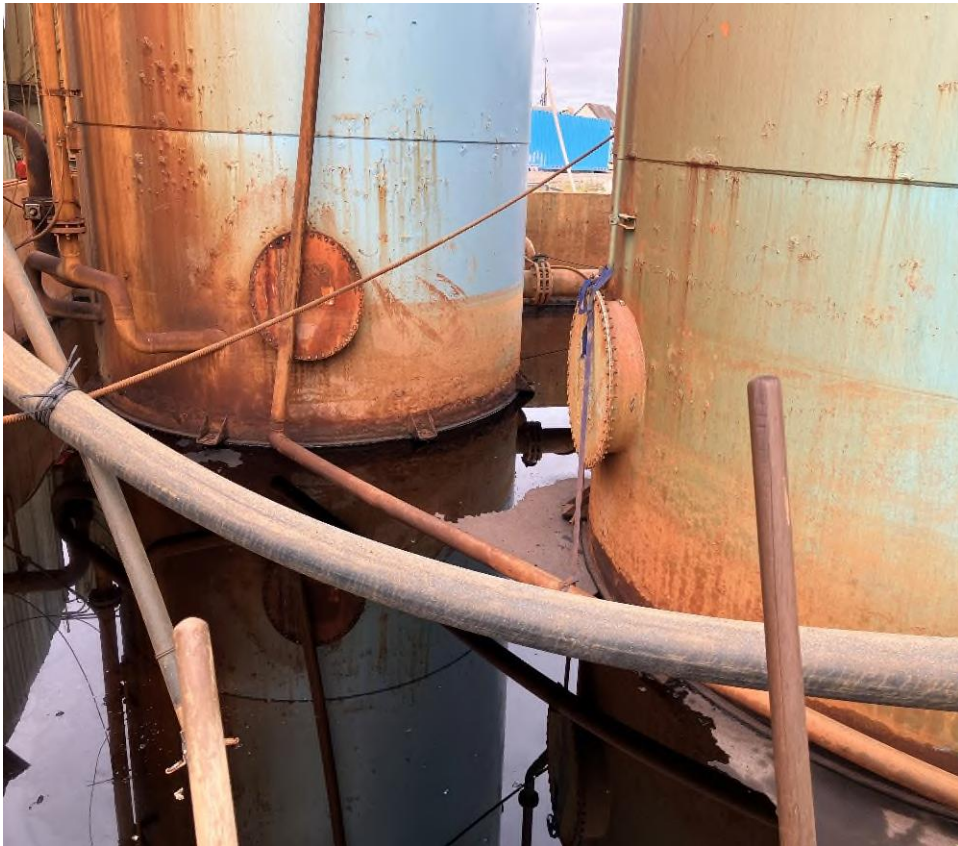
Photo Number: 10  
Date: 8-7-2024  
Comments: Picture of leachate release that occurred within the AST secondary containment.

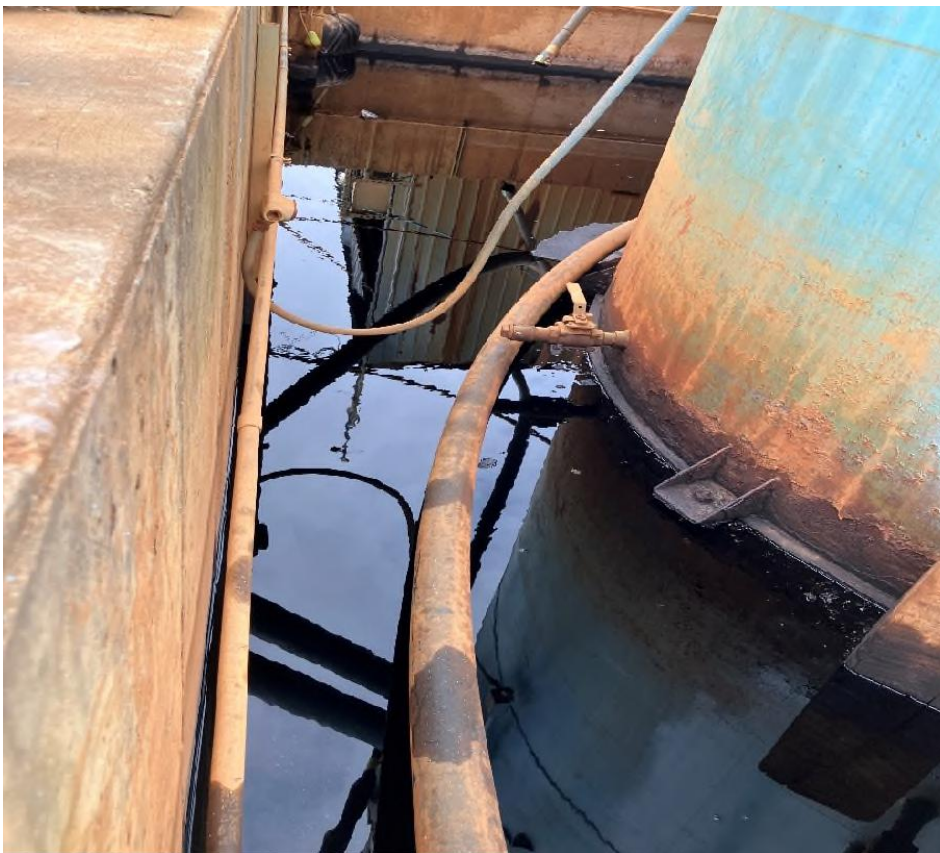
Photo Number: 12  
Date: 8-7-2024  
Comments: Picture of leachate release that occurred within the AST secondary containment.

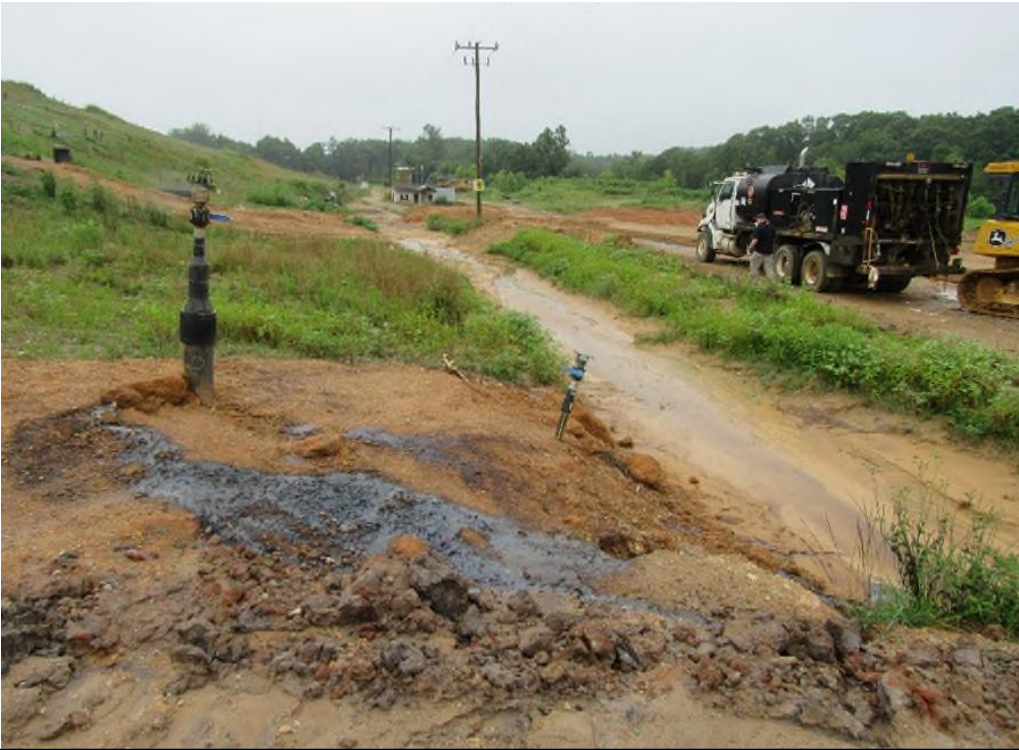
Site Name: Shoosmith SLF Permit# SWP587 Taken By: Jeremy Kazio and Andrew Peal Photo Number: 21  
Date: 6/16/2025 Comments: Storm water ditch inundated with sediment

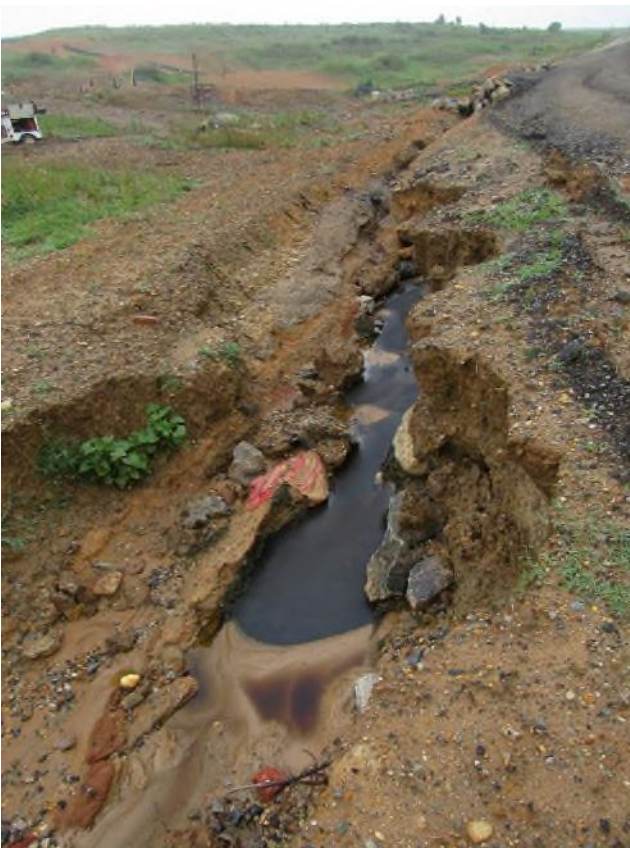
Site Name: Shoosmith SLF Permit# SWP587  
Taken By: Jeremy Kazio and Andrew Peal  
Page 12  
Photo Number: 23  
Date: 6/16/2025  
Comments: Severely eroded storm water ditch

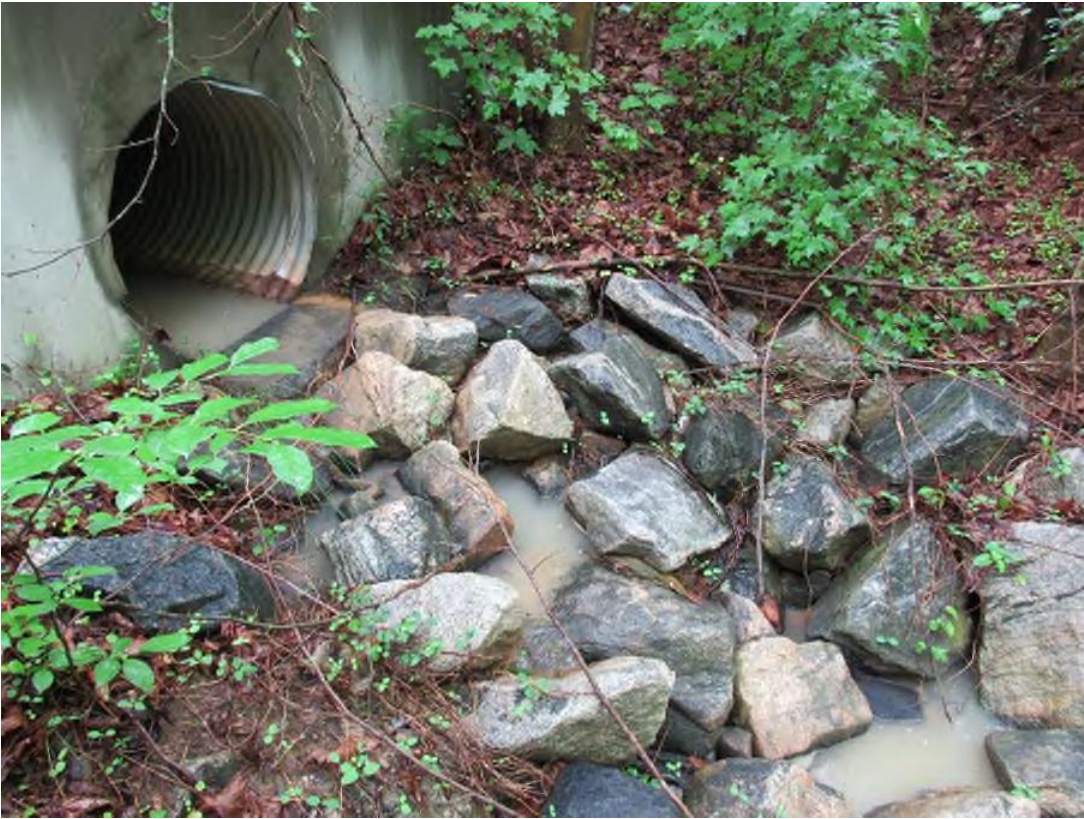
Site Name: Shoosmith SLF Permit# SWP587 Taken By: Jeremy Kazio and Andrew Peal Page 8 Photo Number: 15  
Date: 6/16/2025 Comments: Active discharge from VPDES permitted outfall serving SB-12

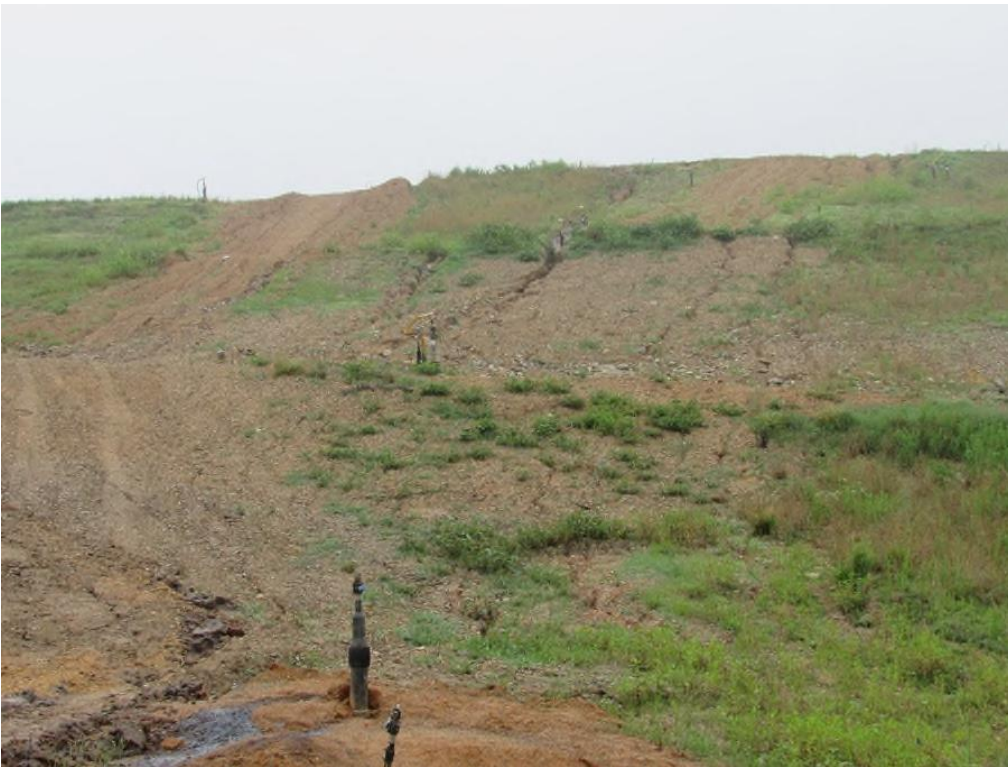
Photo Number: 24  
Date: 6/16/2025  
Comments: Example of excessive rilling (and leachate seep)

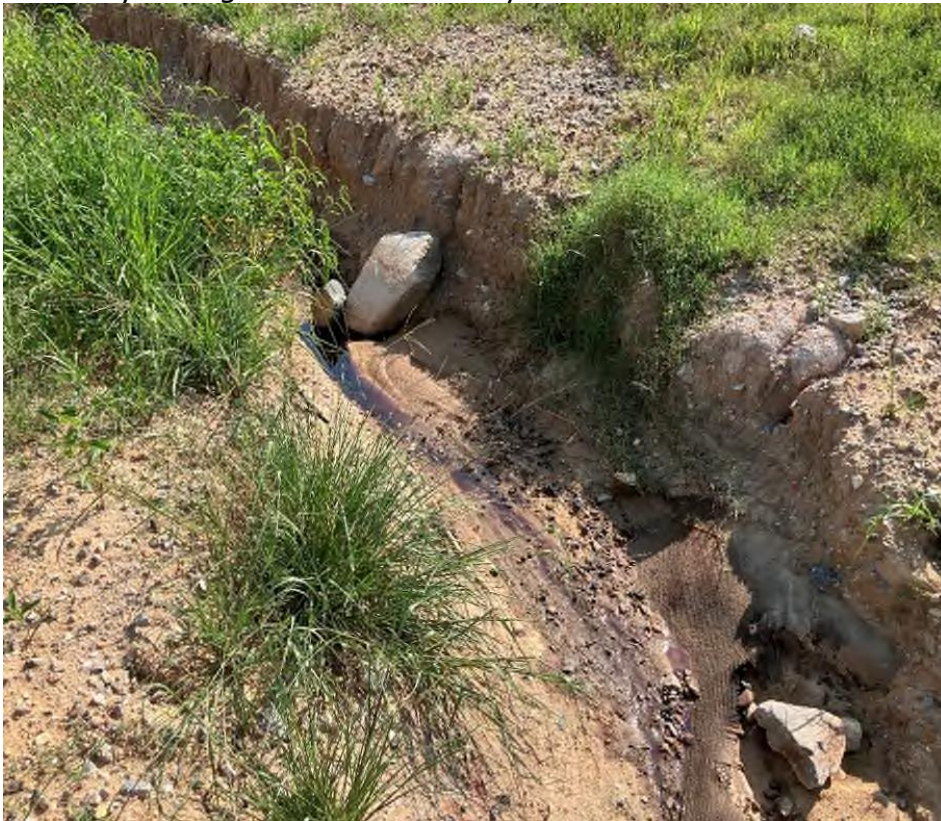
Photo Number: 29

Comments: Picture showing leachate seep flowing in erosion rill on side slope of Cell 26..

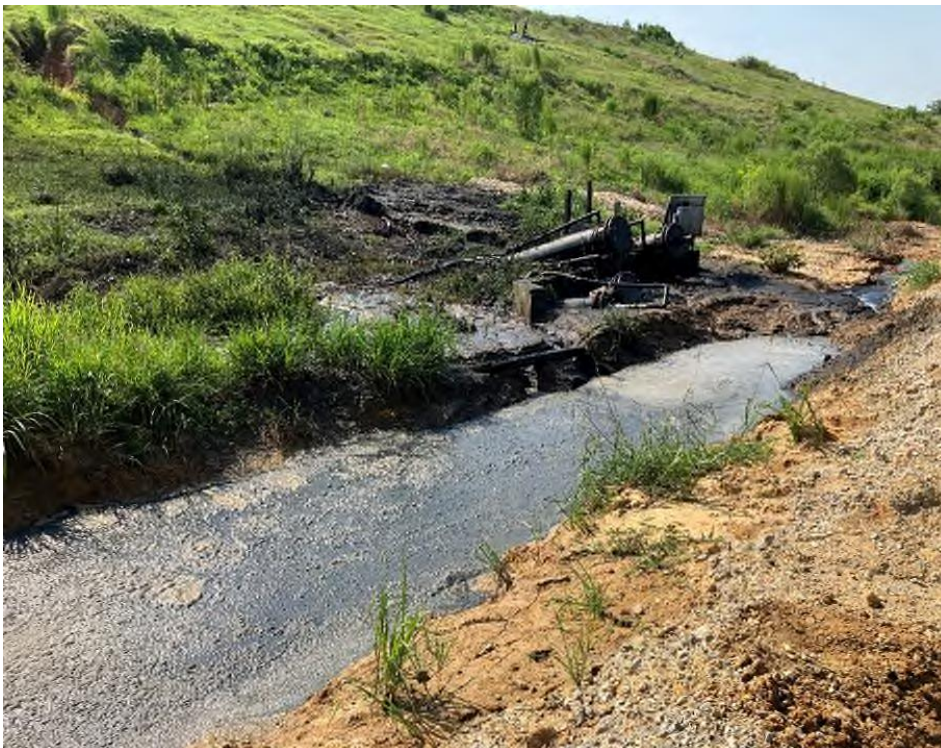
Photo Number: 31

Comments: Picture showing leachate release after maintenance crew hit leachate header pipe at toe of Cell 26.

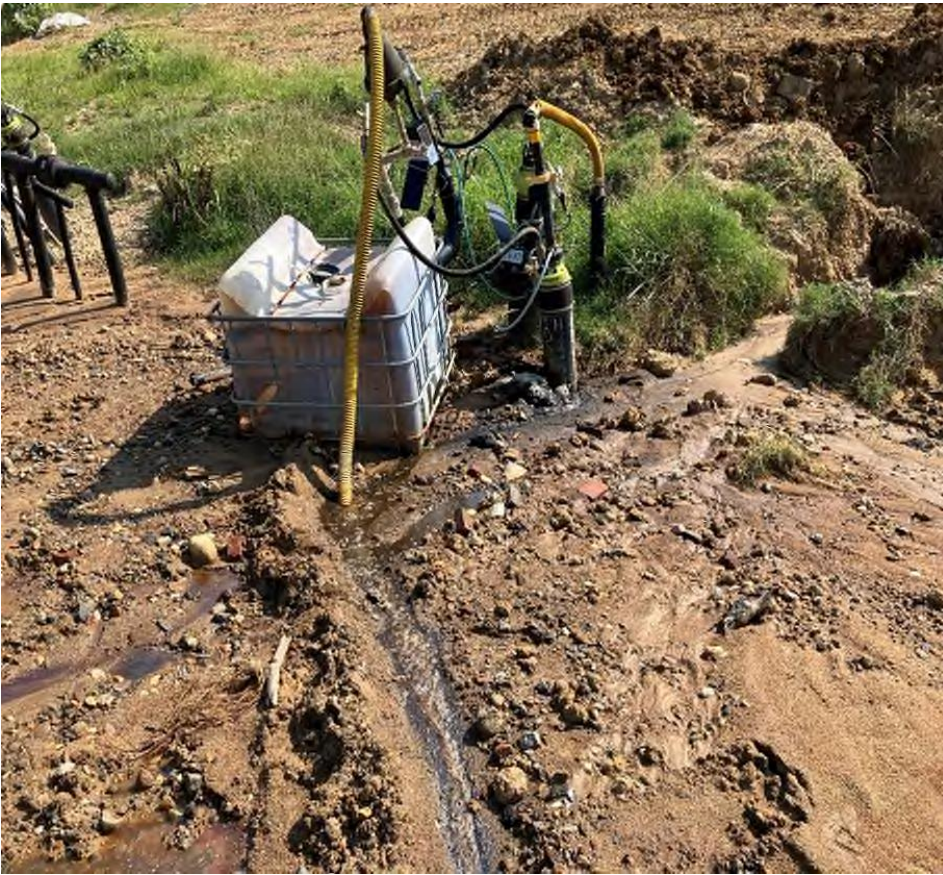
Photo Number: 34

Comments: Picture showing leachate leaking out of gas well on side slope of Cell 24..

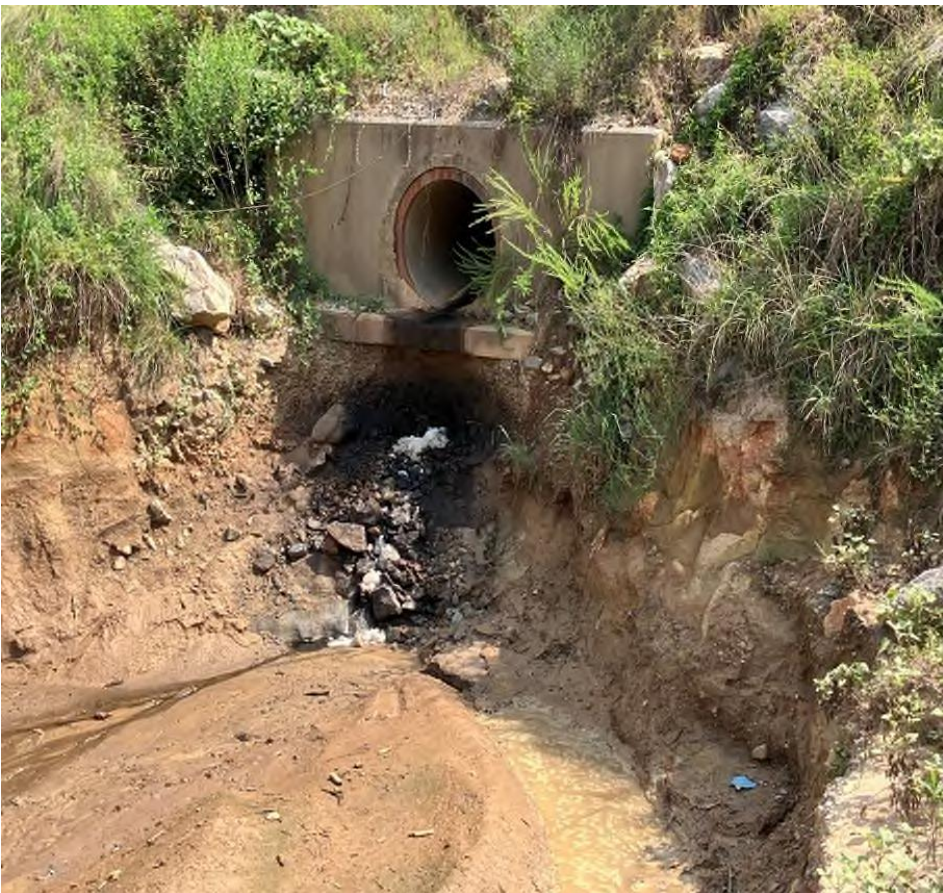
Photo Number: 42

Comments: Picture showing leachate flowing from the stormwater channel inlet at toe of Cell 24, into the forebay at SB-11.

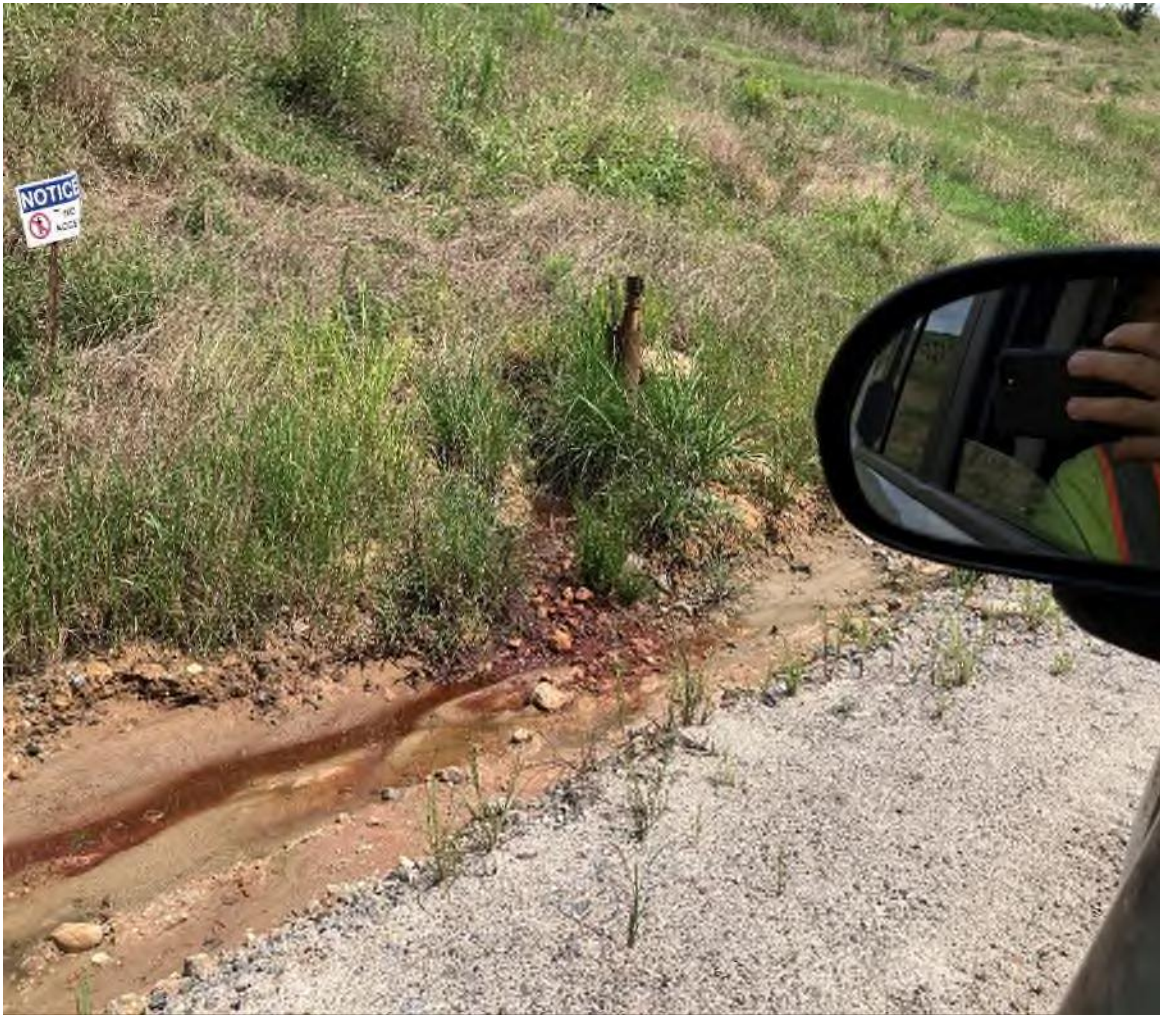
Photo Number: 43 Date: 7-30-2025

Comments: Picture showing leachate flowing into the stormwater channel along the toe of Cell 8.

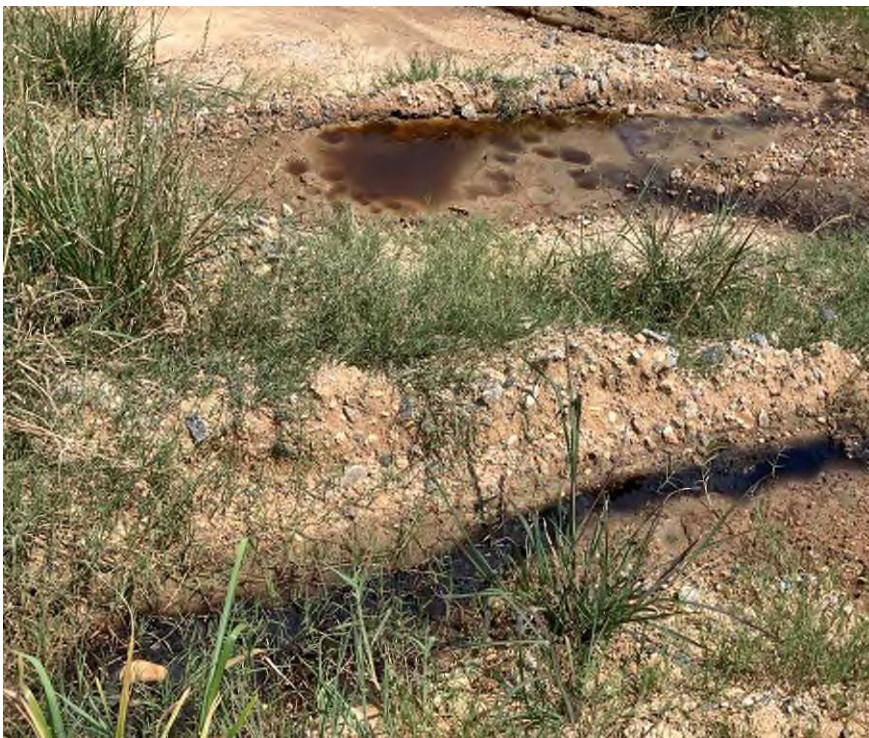
Photo Number: 47 Date: 7-30-2025

Comments: Picture showing leachate within the stormwater channel from release at sump 23.
